## APPENDIX G – REFERENCE REPORTS

| Description |
|---|
| Building Condition Assessment Report for Cochrane Powerhouse – September 19, 2022 – Prepared by Roth IAMS |

**Ontario Northland Transportation  
Commission**

**Building Condition Assessment Report**

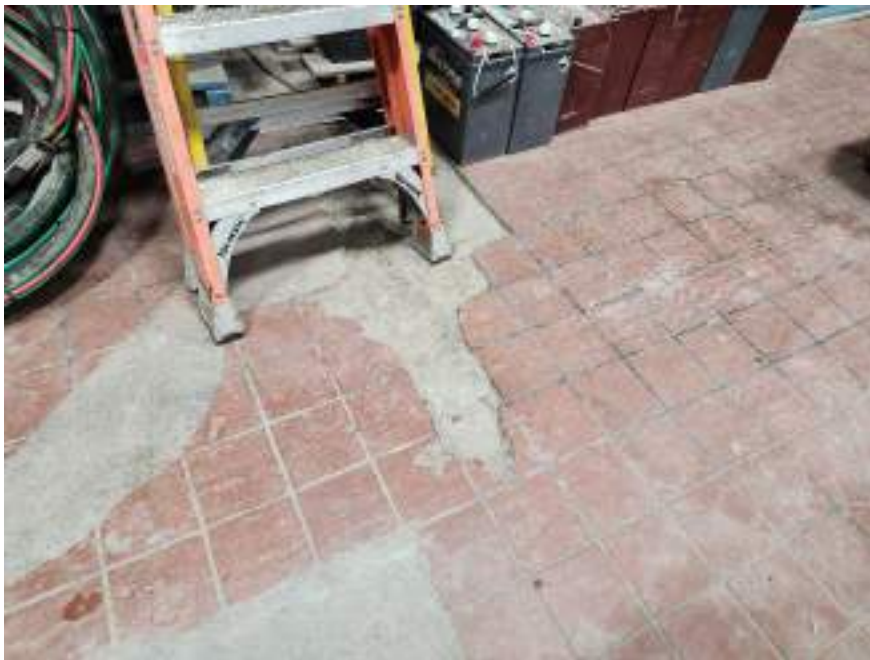
*Figure 8: Flooring defects*

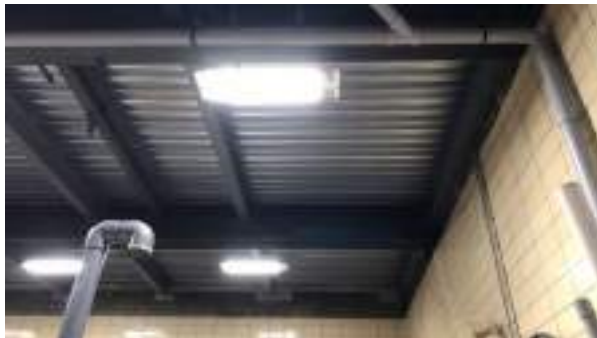
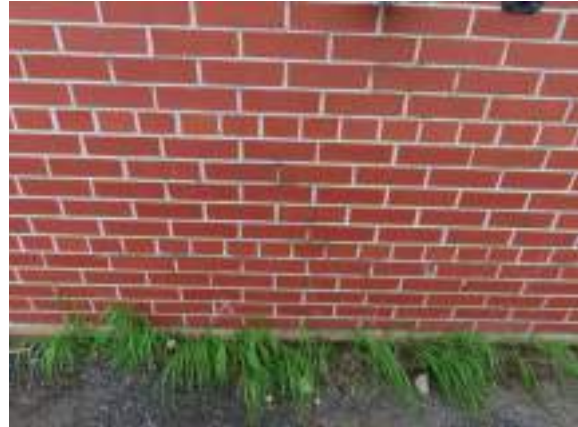
Cochrane Powerhouse - B103001

Stress cracks on the bricks of the exterior walls were observed at various locations. Repairs to the brick wall had occurred previously. Given the past wall repair and roof structure history, and based on the observed condition, a study to check the condition of the structure and exterior walls, and subsequent repairs are recommended. The R value of the exterior walls is reportedly very low. The installation of insulating foam during major repair of the walls is recommended.

| <b>Table 2 - Capital and Maintenance Renewals in 2023 - 2026</b> | | | | |
|---|---|---|---|---|
| B103001 | Structure | The R value of the exterior walls is reportedly very low. The installation of insulating foam during major repair of the walls is recommended. | 2023 | \$200,000 |

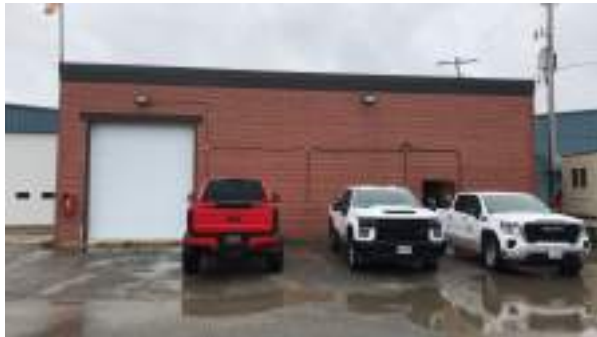
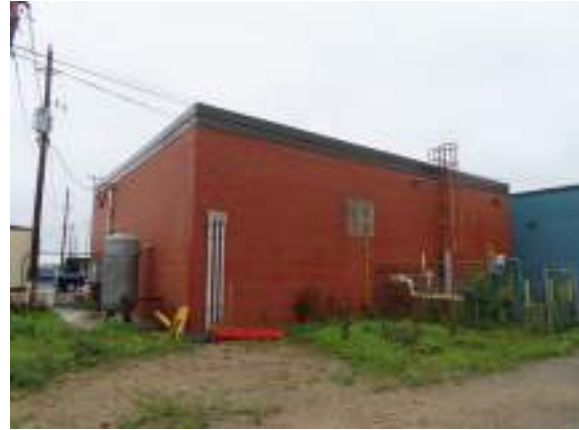
Cochrane Powerhouse - B201021

Stress cracks on the bricks at various locations were observed. At the northwest corner of the building, the original bricks have been replaced with concrete; the site representative noted that deficiencies (spalled brick and cracks) had occurred at this location and repairs were undertaken. As recommended under B103001 Structure, a study to check the condition of the exterior walls and subsequent repairs have been recommended.

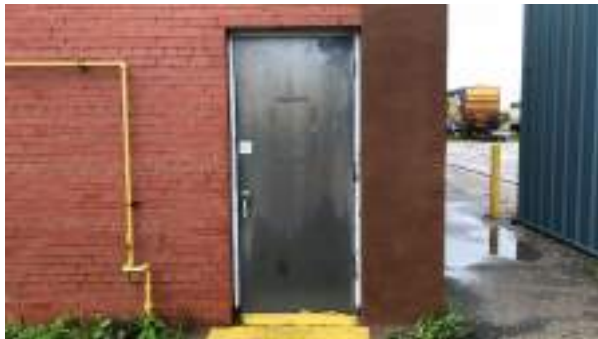
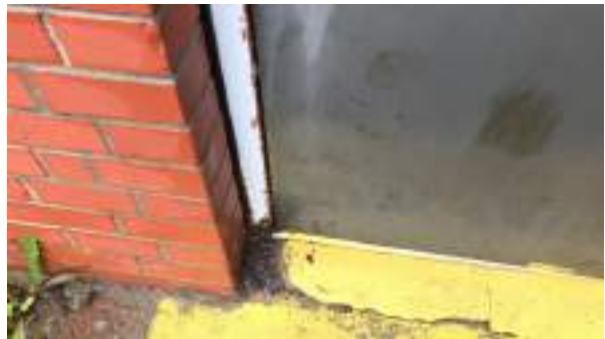
Cochrane Powerhouse - B203023

Corrosion on the doors and frames were observed. With continued exposure to the elements, the current condition is anticipated to progress. Lifecycle replacement is recommended.

| <b>Table 2 - Capital and Maintenance Renewals in 2023 - 2026</b> | | | | |
|---|---|---|---|---|
| B203023 | Exterior Single-Door | Replace Exterior Single-Door | 2023 | \$10,400 |

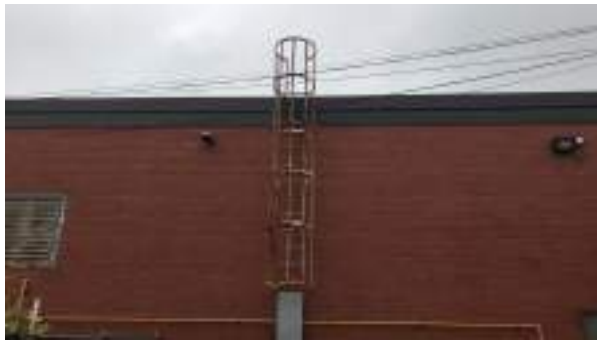
Cochrane Powerhouse - C201001

Corrosion on the ladder and cage were observed. Continued exposure to the elements may accelerate the deterioration, and this may further weaken the ladder. Based on age and observed condition, replacement of the steel framed ladder is recommended.

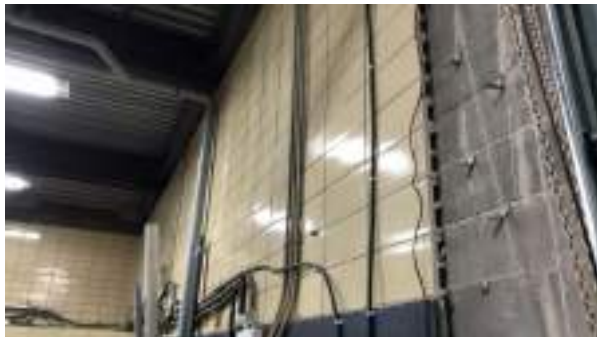
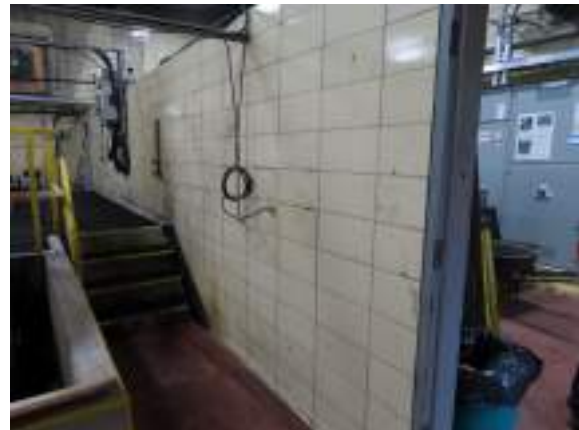
Cochrane Powerhouse - C301023

The ceramic tiles are heavily stained and have exceeded their expected useful life. Lifecycle replacement is recommended. The cost has been increased to cover costs for electrical equipment relocation.

| <b>Table 2 - Capital and Maintenance Renewals in 2023 - 2026</b> | | | | |
|---|---|---|---|---|
| C301023 | Ceramic Wall Tile | Replace Ceramic Wall Tile | 2025 | \$273,000 |

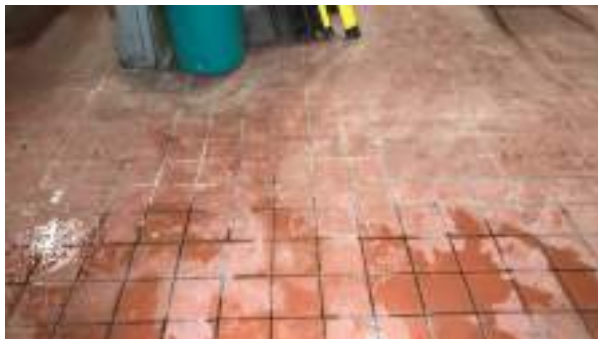
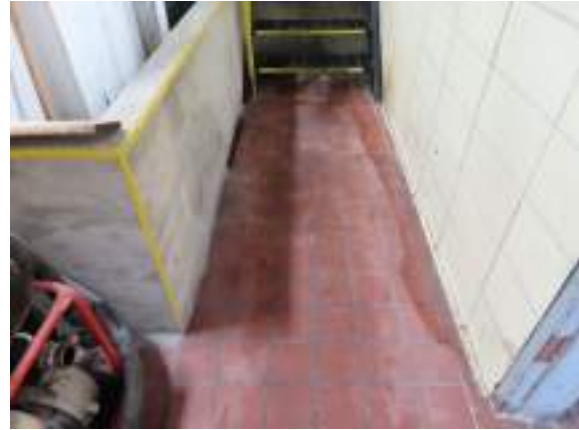
Cochrane Powerhouse - C302001

Damaged, missing, and stained quarry tiles were observed. Lifecycle replacement is recommended. Deferral of the replacement may result in the increase in potential of tripping hazards.

| Table 1 - Immediate Term (2022) | | | | |
|---|---|---|---|---|
| C302001 | Ceramic / Porcelain Tile Floor Cover | Replace Ceramic / Porcelain Tile Floor Cover | 2022 | \$119,925 |

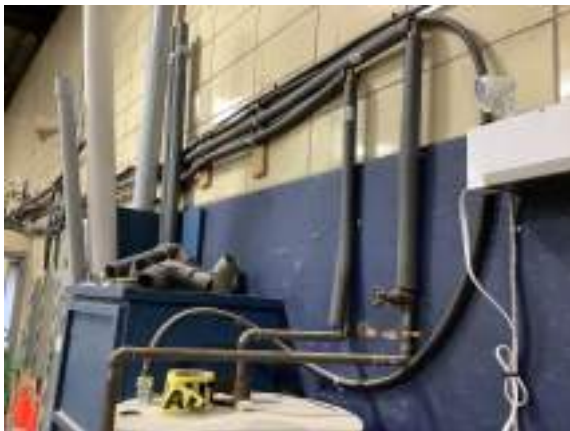
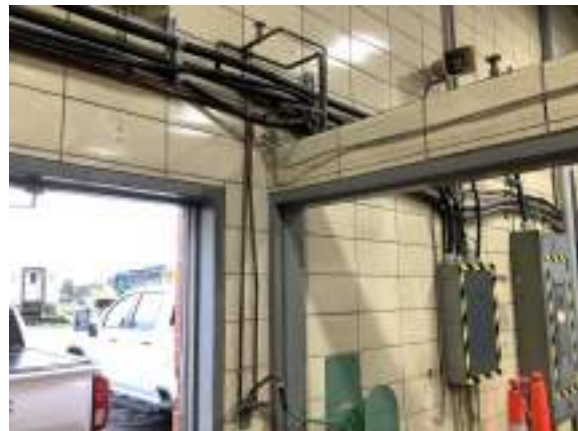
Cochrane Powerhouse - D202001

No significant deficiencies were observed or reported. However, the system appears to be original to building construction and can experience pipe fatigue over time which can result in failure. Lifecycle replacement is recommended.

| <b>Table 2 - Capital and Maintenance Renewals in 2023 - 2026</b> | | | | |
|---|---|---|---|---|
| D202001 | Domestic Water Pipes and Fittings | Replace Domestic Water Pipes and Fittings | 2025 | \$32,110 |

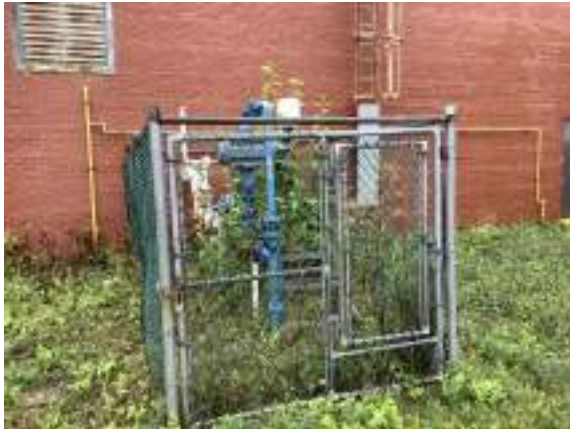
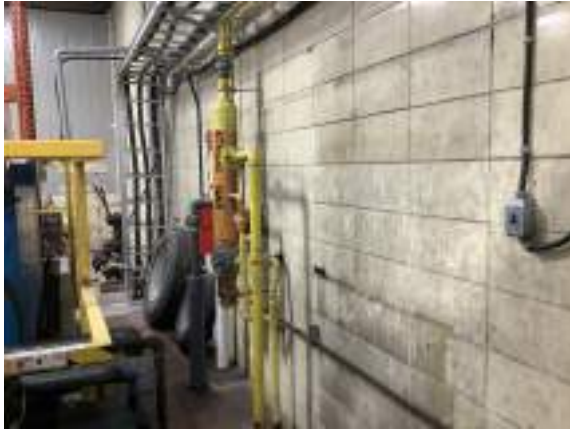
Cochrane Powerhouse - D301002

No significant deficiencies were observed or reported. However, the system appears to be original to building construction and can experience gas leaks over time. Lifecycle replacement is recommended.

| <b>Table 2 - Capital and Maintenance Renewals in 2023 - 2026</b> | | | | |
|---|---|---|---|---|
| D301002 | Gas Supply Systems | Replace Gas Supply Systems | 2023 | \$16,055 |

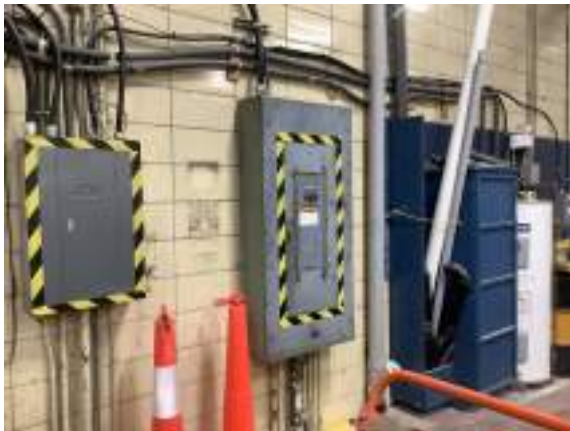
Cochrane Powerhouse - D501005

No significant deficiencies were observed or reported. However, the system appears to be original to building construction and can experience electrical or thermal breakdown over time. Lifecycle replacement is recommended.

| Uniformat II | Uniformat Name | Description | Action Year | Budget Cost (\$) |
|---|---|---|---|---|
| D501005 | Secondary Distribution Panelboards | Replace Secondary Distribution Panelboards | 2022 | \$39,000 |
| D501005 | Secondary Distribution Panelboards | To account for potential changes to the electrical distribution, recommend a Coordinated and Arc Flash Study be undertaken, every five years, prior to lifecycle replacement or major renovations. | 2022 | \$28,800 |
| D501005 | Secondary Distribution Panelboards | In anticipation of either a major repair or a lifecycle replacement, recommend the preparation of a single-line diagram. | 2022 | \$9,600 |

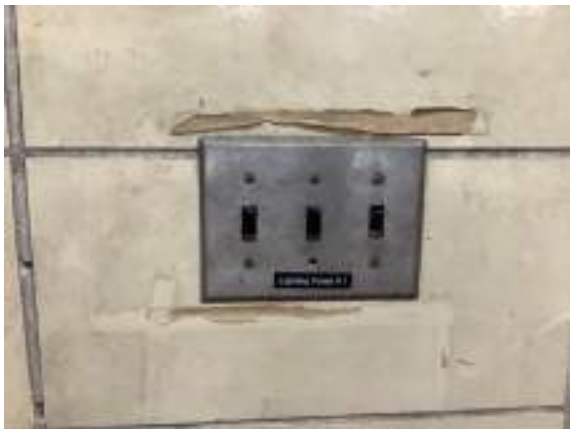
Cochrane Powerhouse - D502001

No significant deficiencies were observed or reported. However, the branch wiring appears to be original and can experience insulation breakdown over time which can eventually result in failure. Replacement is recommended.

| Uniformat II | Uniformat Name | Description | Action Year | Budget Cost (\$) |
|---|---|---|---|---|
| D502001 | Branch Wiring and Devices | Replace Branch Wiring and Devices | 2022 | \$76,261 |

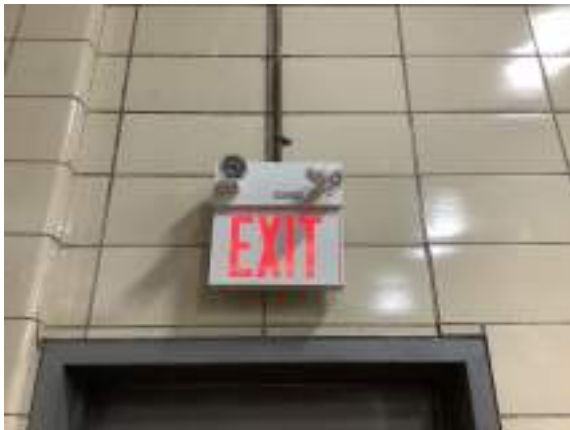
Cochrane Powerhouse - D502003

No significant deficiencies were observed or reported. Upgrade to pictogram exit signs should be considered.

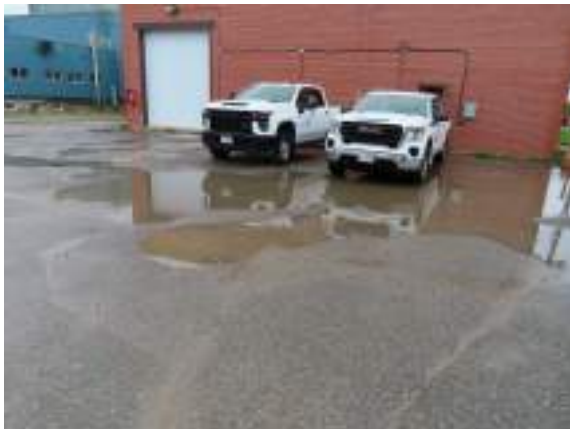
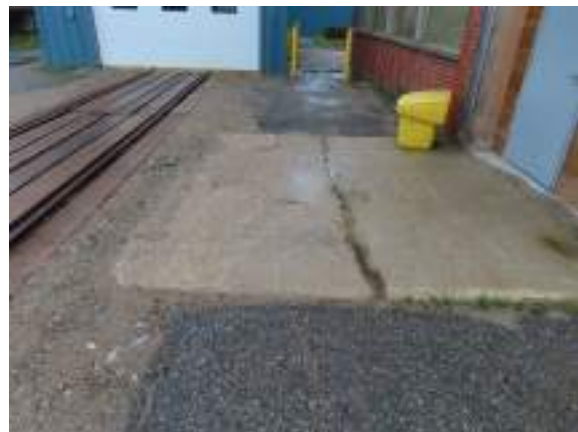
Cochrane Powerhouse - G202003

Deterioration in the form of raveling and potholes appears to be systemic to the asphalt paved surface. The potholes appear to impede efficient stormwater drainage from site. Cracks on the concrete flatwork was observed. Replacement of the paved surfaces is recommended. The replacement cost has been increased to accommodate expenditures to create a stormwater management plan and installation of catch basins.

| <b>Table 2 - Capital and Maintenance Renewals in 2023 - 2026</b> | | | | |
|---|---|---|---|---|
| G202003 | Parking Paved Surface | Replace Parking Paved Surface | 2023 | \$348,563 |

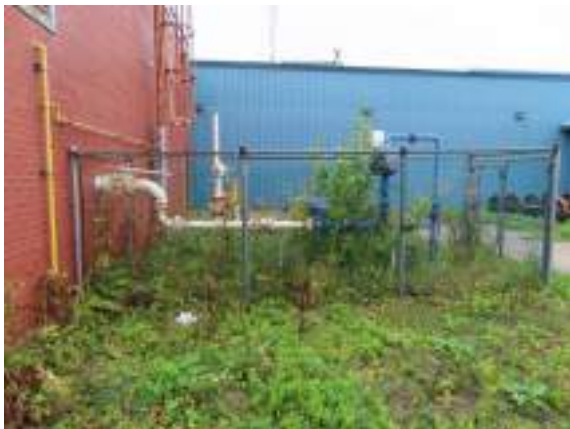
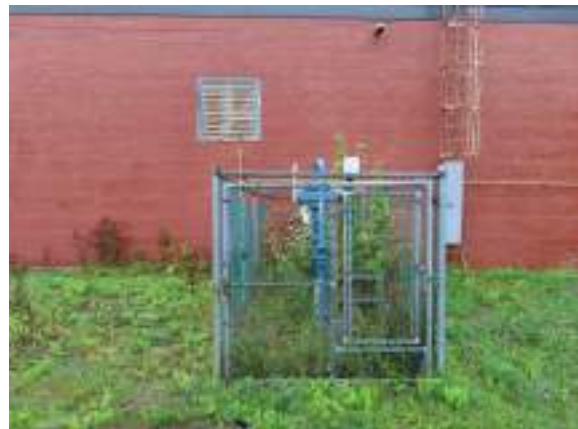
Cochrane Powerhouse - G204001

No significant deficiencies were observed. Although it appears the chain-link fence has surpassed its expected useful life, based on current condition, lifecycle replacement may be deferred.
