## APPENDIX G – REFERENCE REPORTS

| Description |
|---|
| Building Condition Assessment Report for Cochrane Powerhouse – September 19, 2022 – Prepared by Roth IAMS |

**Ontario Northland Transportation  
Commission**

**Building Condition Assessment Report**

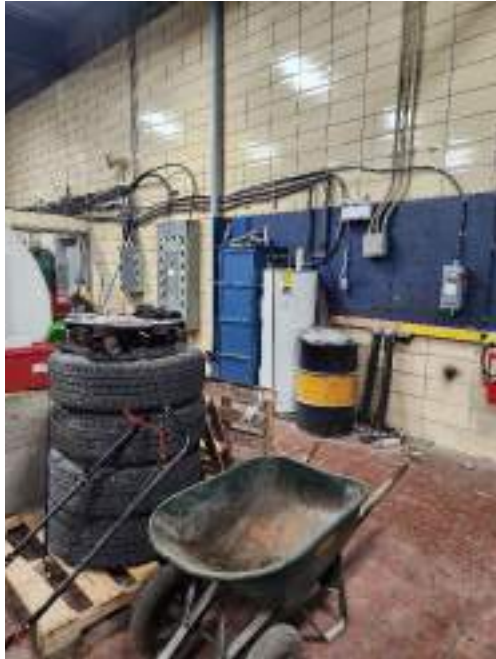
*Figure 5: Cochrane Powerhouse, electrical panels and fire extinguisher*

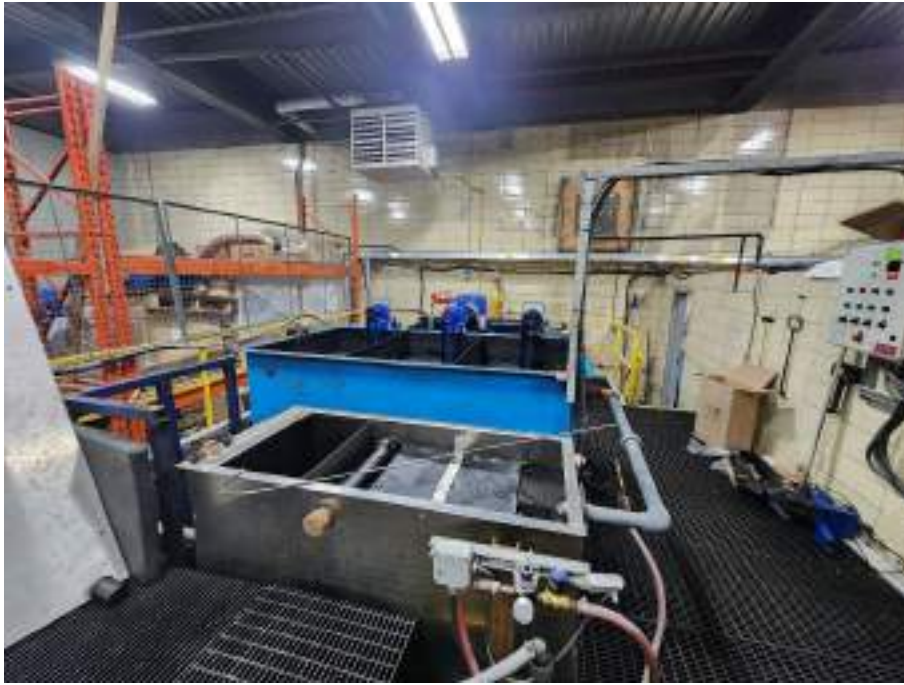
*Figure 9: Oil/ water separation tanks and ventilation*

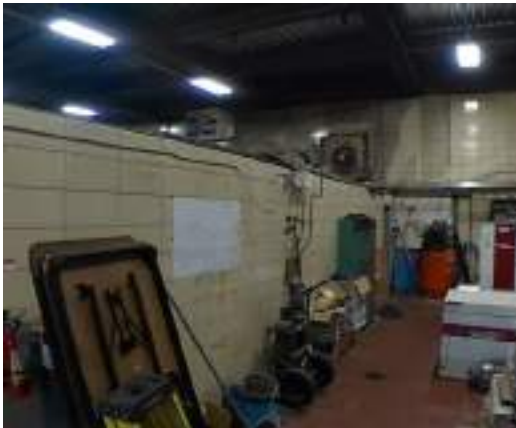
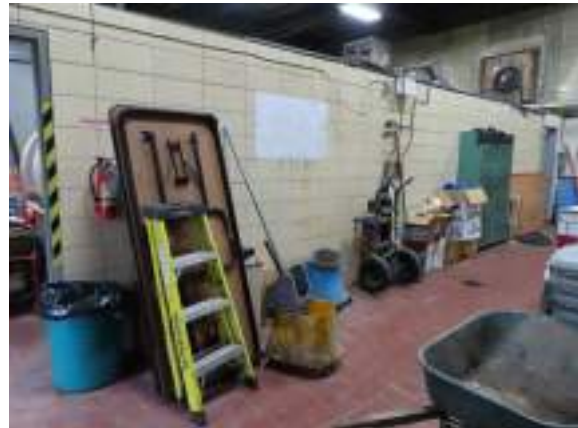
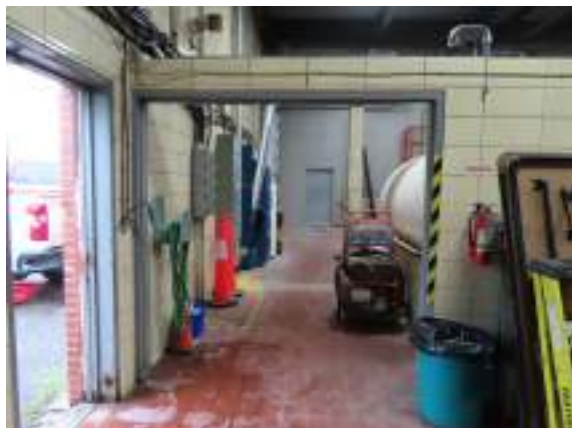
No significant deficiencies were observed or reported.

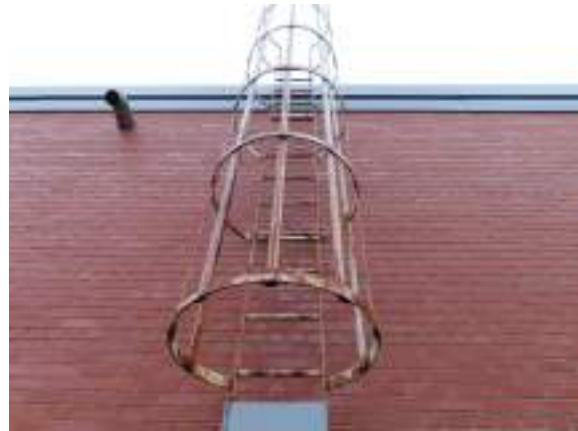
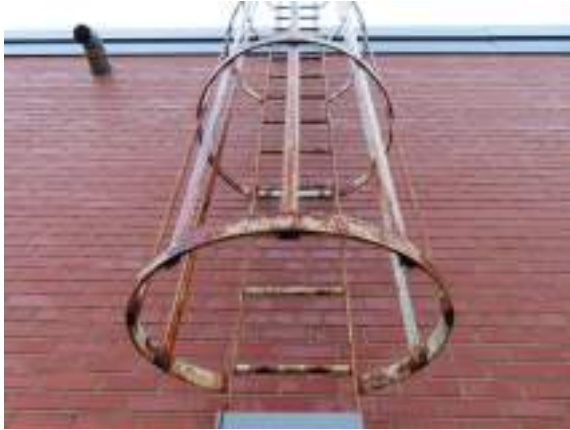
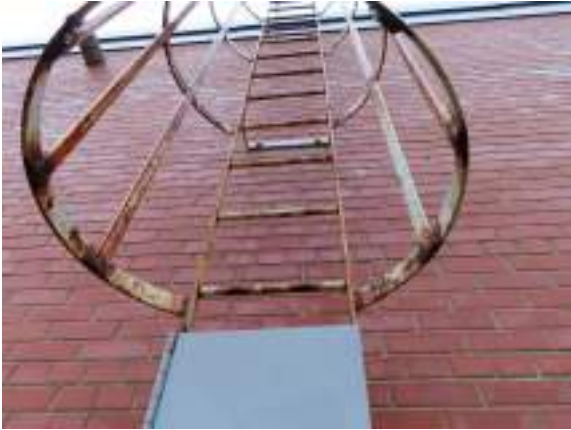
Corrosion on the ladder and cage were observed. Continued exposure to the elements may accelerate the deterioration, and this may further weaken the ladder. Based on age and observed condition, replacement of the steel framed ladder is recommended.

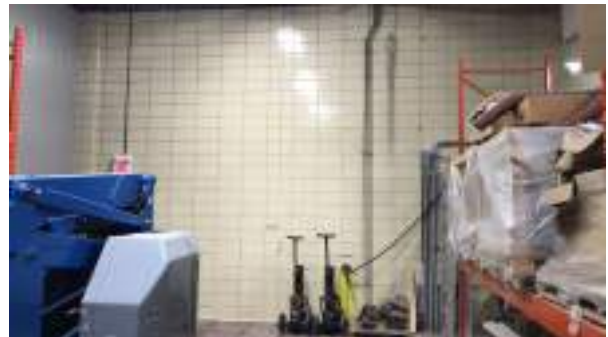
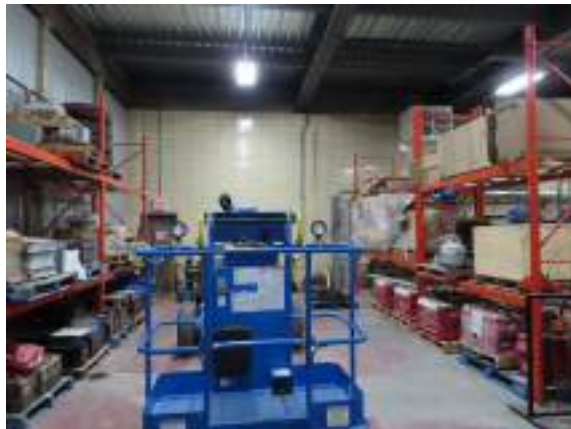
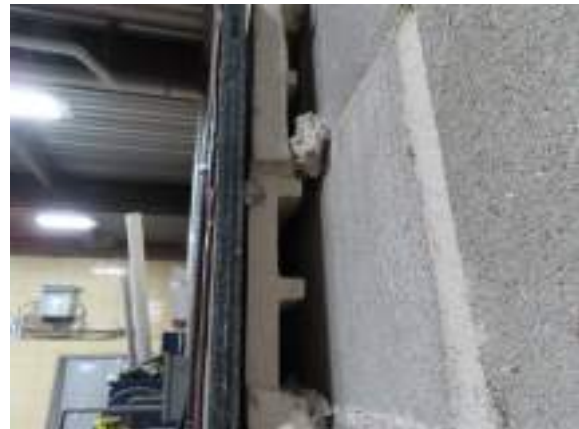
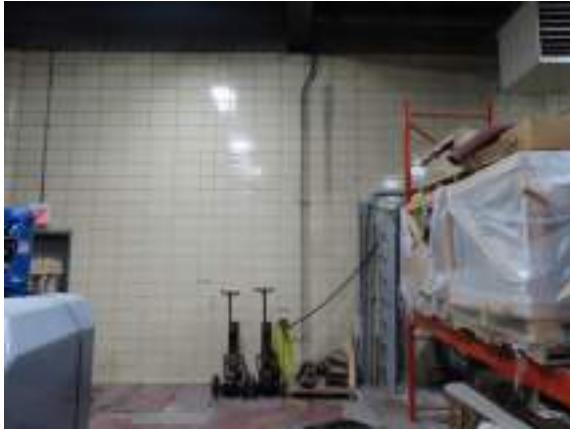
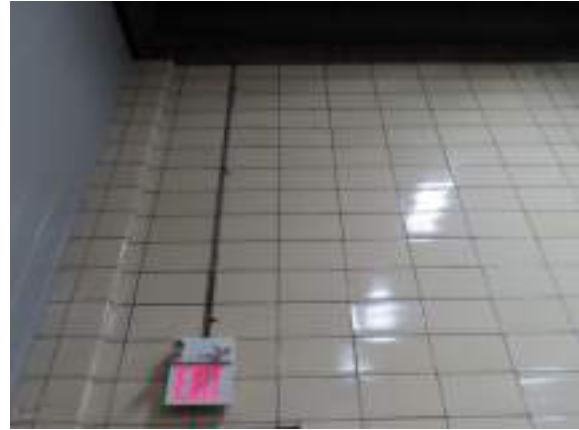
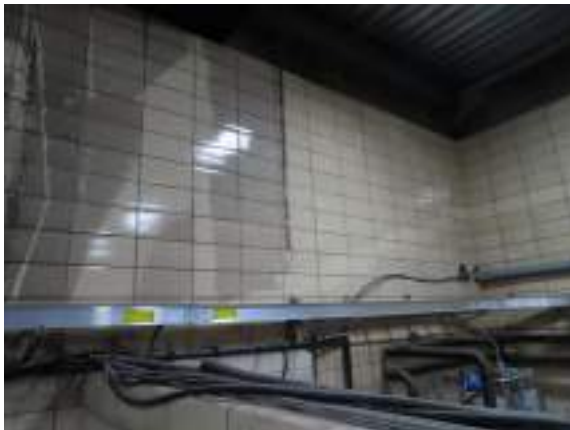
The ceramic tiles are heavily stained and have exceeded their expected useful life. Lifecycle replacement is recommended. The cost has been increased to cover costs for electrical equipment relocation.

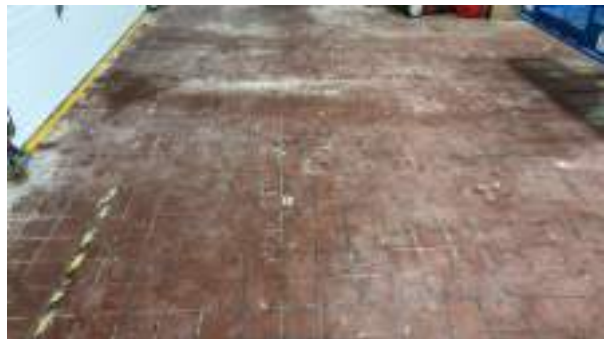
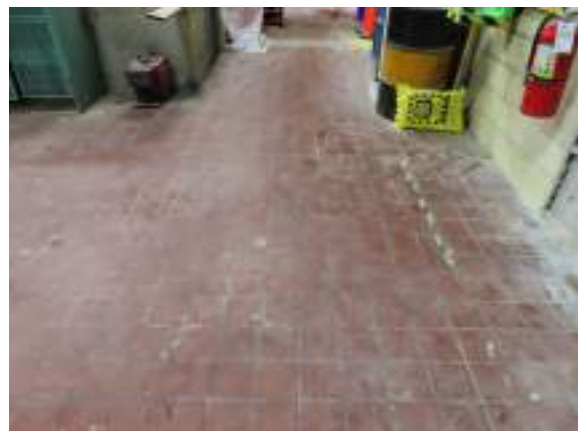
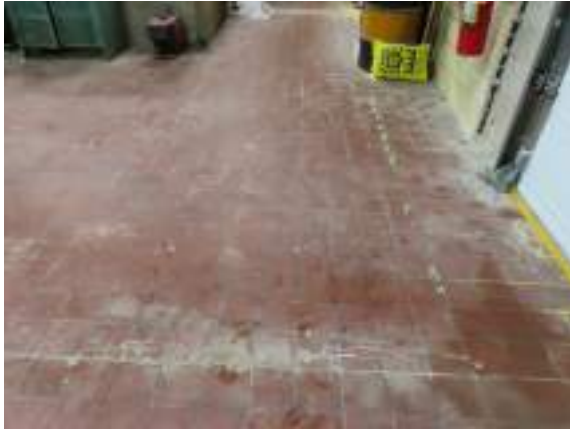
Damaged, missing, and stained quarry tiles were observed. Lifecycle replacement is recommended. Deferral of the replacement may result in the increase in potential of tripping hazards.

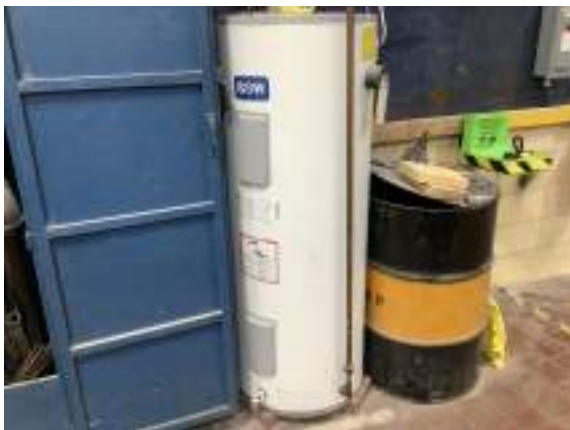
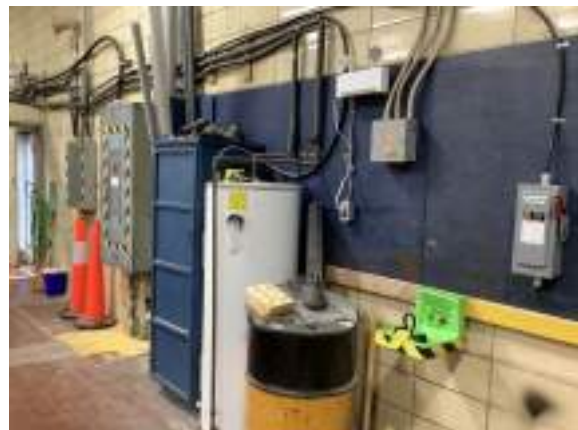
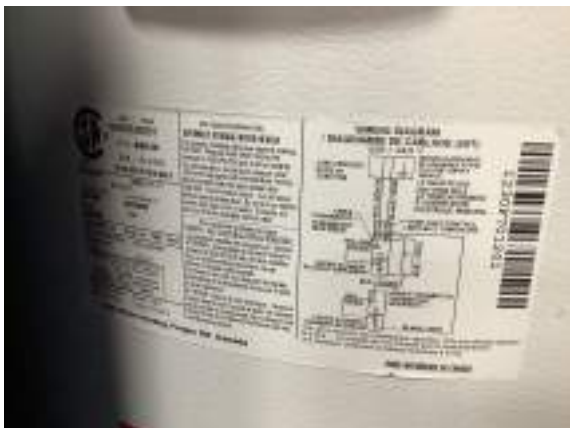
No significant deficiencies were reported or observed.

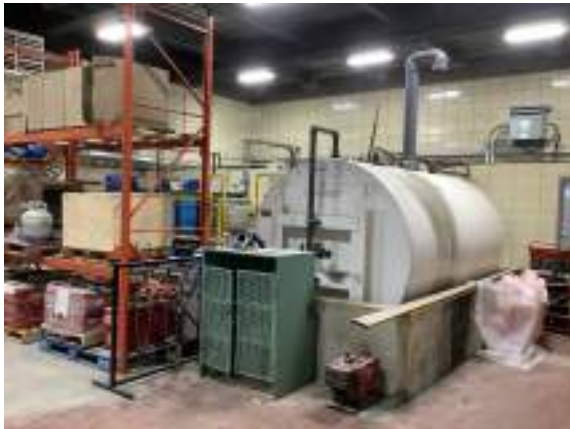
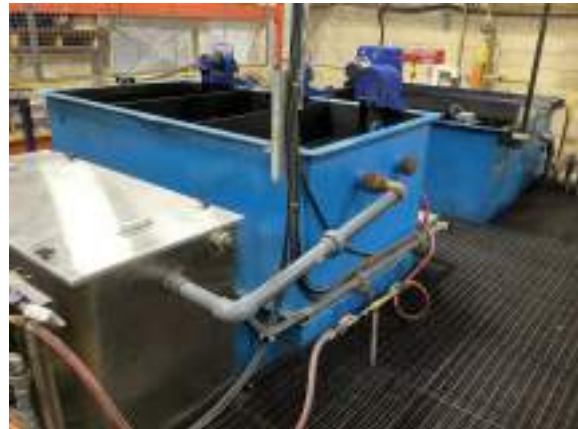
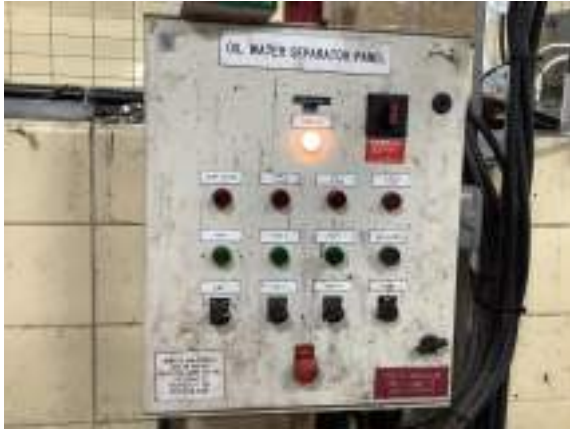
No significant deficiencies were reported or observed. Some of the piping may be original to building construction.

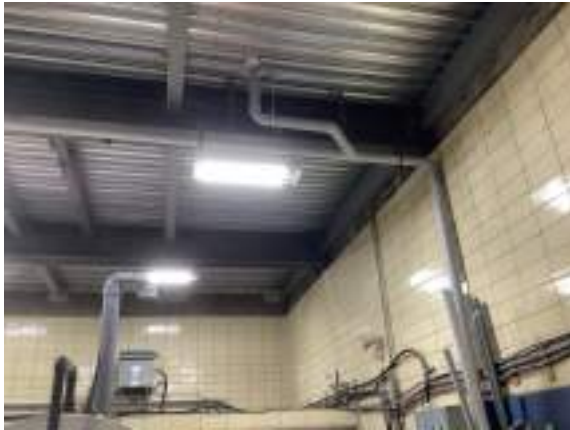
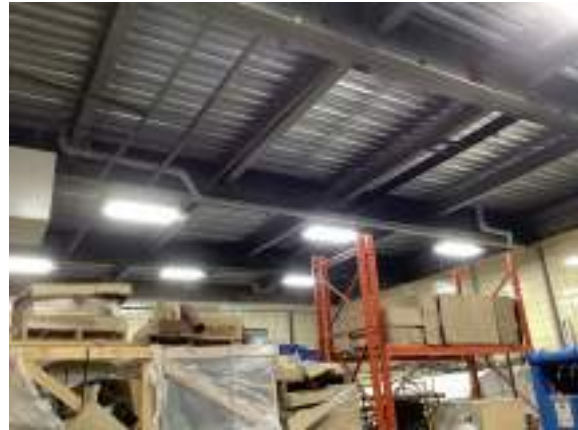
No significant deficiencies were observed or reported.

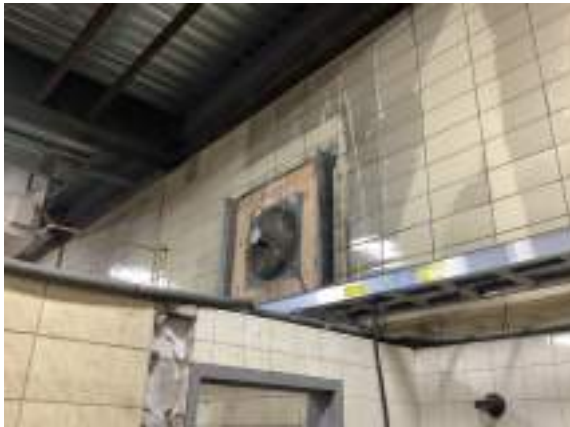
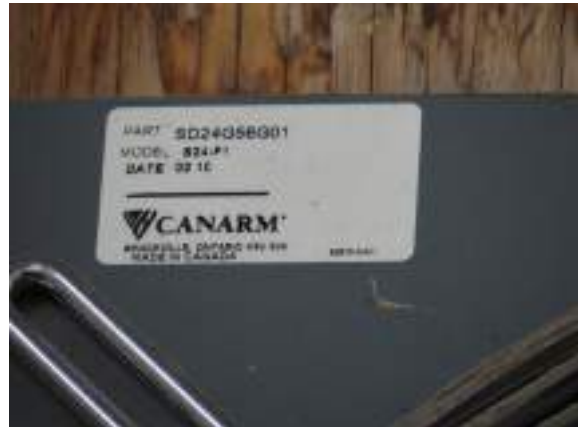
No significant deficiencies were observed or reported.

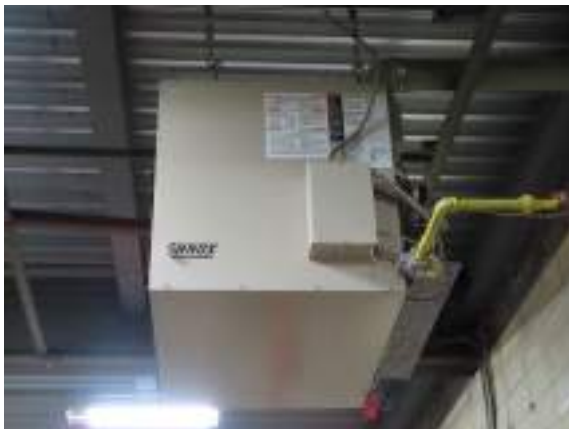
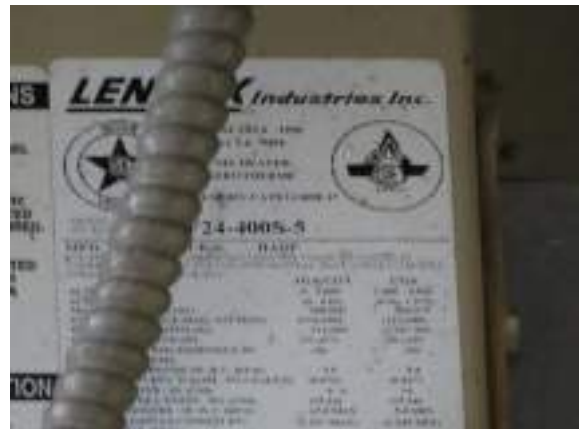
No significant deficiencies were observed or reported.

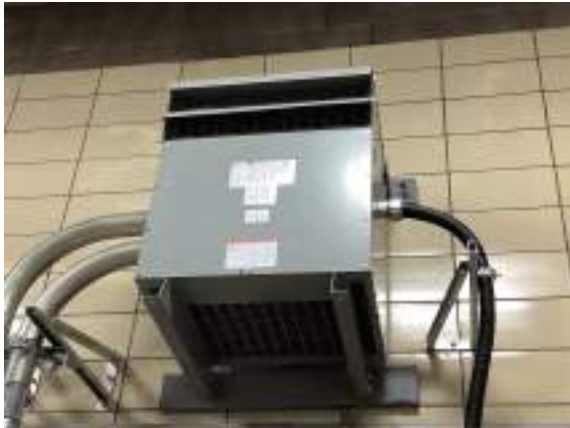
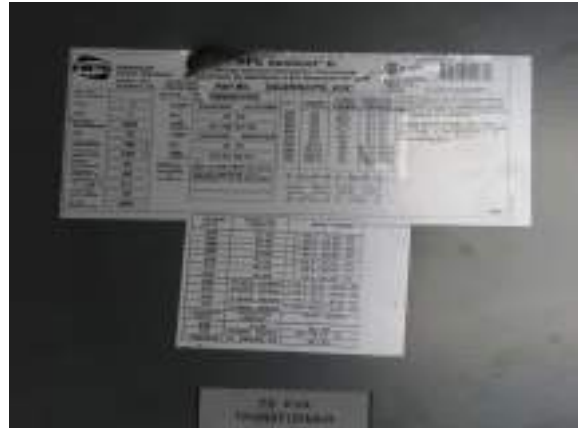
No significant deficiencies were observed or reported.

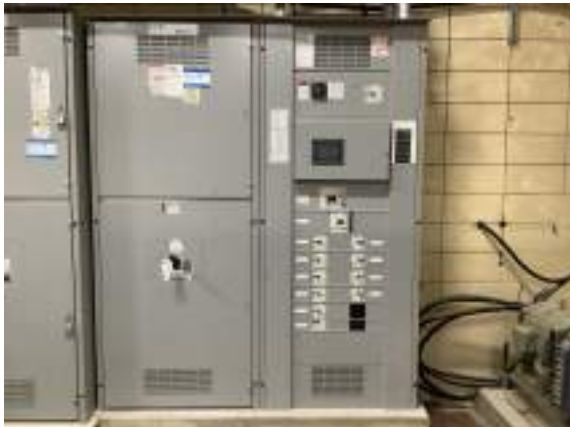
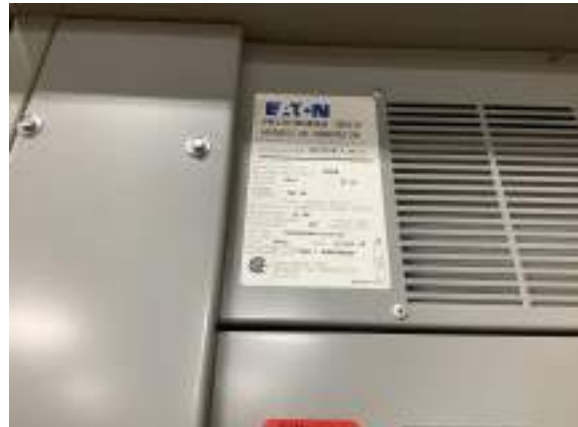
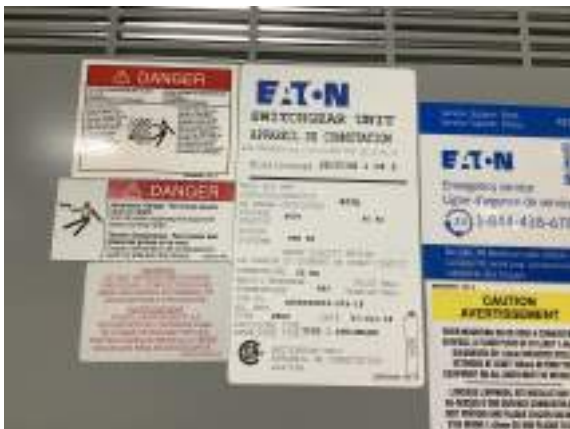
No significant deficiencies were observed or reported.

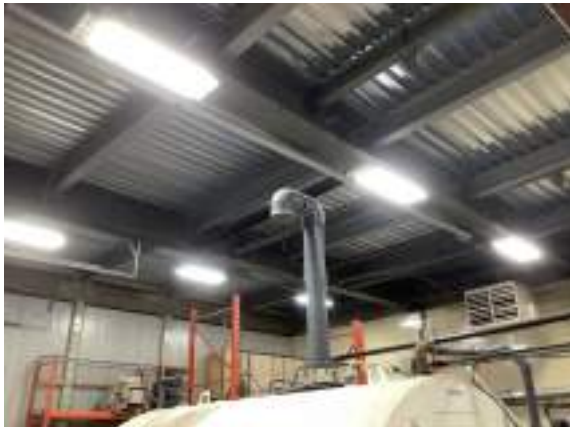
No significant deficiencies were observed or reported. The lighting was reportedly upgraded to LED in 2019.

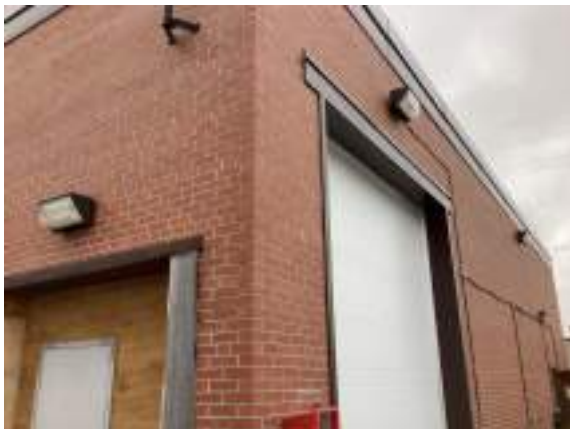
No significant deficiencies were observed or reported. The lighting was reportedly upgraded to LED in 2019.

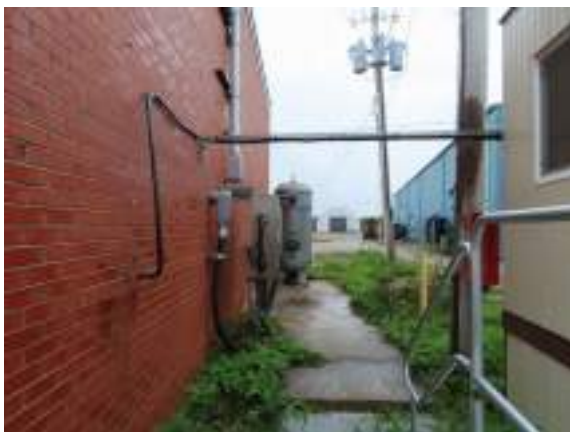
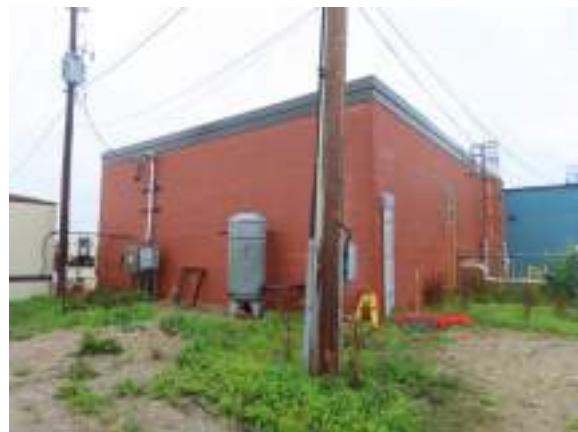
Cochrane Powerhouse - G205004

The landscaping is generally unkempt. A cost allowance for refurbishment is provided.

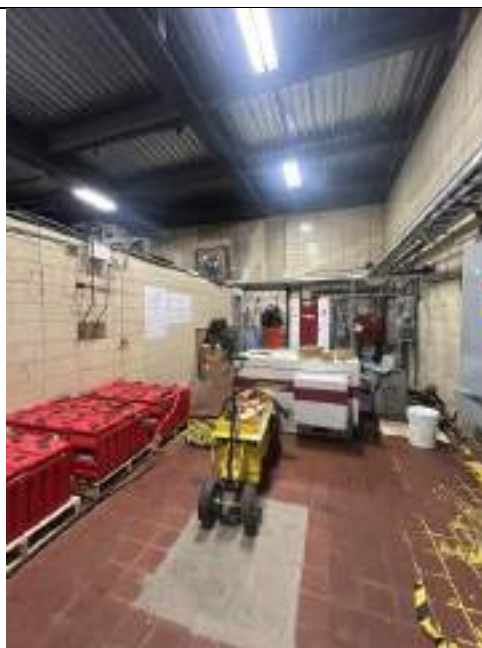
Picture 1.8 - Overall Photo (Building South)

- 3) Some floor patching was observed at the South end of the existing facility (see Photo 1.8). Based on the rectangular shape of the patching there was likely a piece of equipment with a concrete housekeeping pad that was removed at this location. With the configuration of the space it is unlikely that heavy equipment can access the Central or South areas of the existing building.

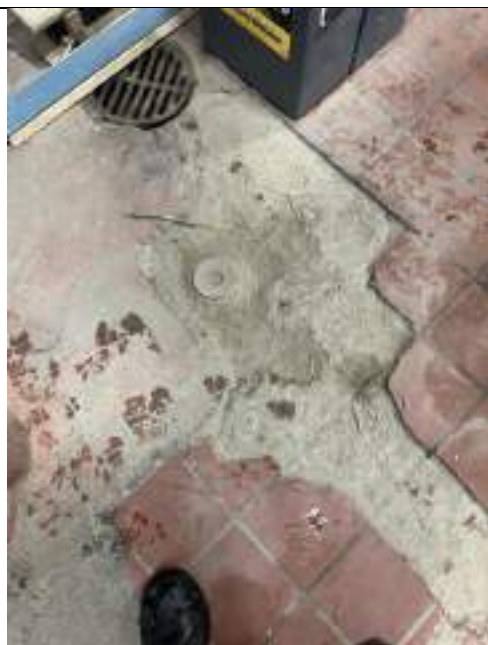
Picture 2.1 - Existing Flooring (Building North)

- 1) The existing ceramic floor tile was noted to be missing and cracked at various locations at the North end of the existing facility (see Photo 2.1-2.3). The deterioration is likely caused by the use of heavy equipment (forklift or telehandler).

- 2) At one floor drain (Photo 2.1), it was noted that the concrete below the tile had deteriorated. Cause of concrete deterioration is unknown. The concrete slab appeared to be in good condition otherwise, no visible cracking was observed.

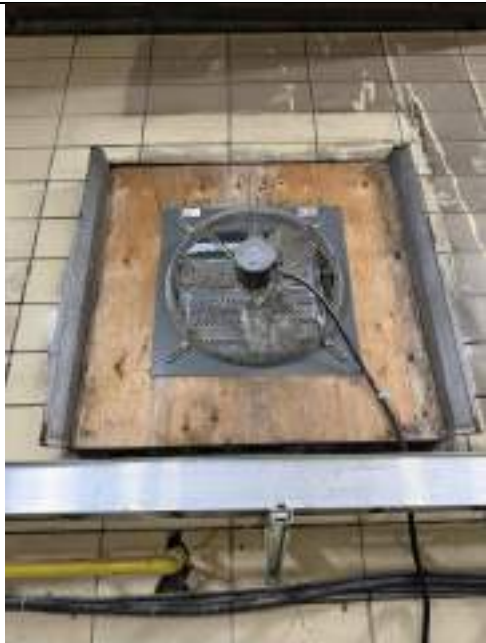
The only mechanical means of ventilation in the building is provided by an axial wall exhaust fan (see Photo 3.6). The fan is controlled only by an ON/OFF switch on the wall. This fan was installed in 2010 and was manufactured by CANARM, the capacity of the fan is not known. Building occupants have reported that the fan is incapable of removing odours originating from the oil separator.

Picture 3.6 - Existing exhaust fan

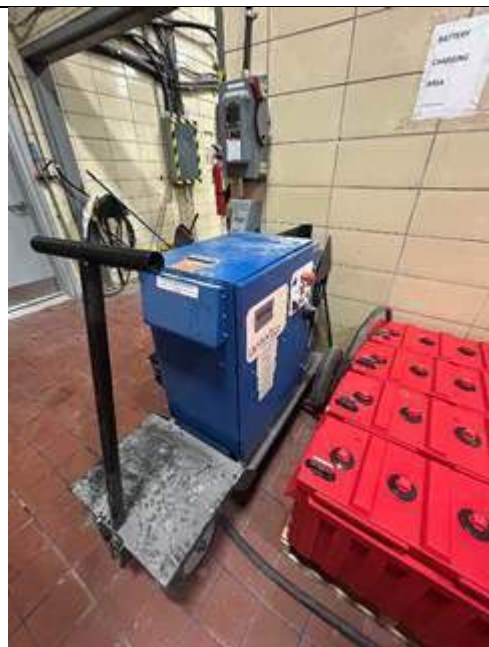
Lead-acid and NiCd batteries are stored and charged within the building placed on the floor, as well as on wooden pallets (see Photo 4.1 and Photo 4.2). Batteries are charged with a portable industrial battery charger, (see Photo 4.3), as well as a wall mounted battery charger "BATTERY CHARGER B" (see Photo 4.4)

**Picture 4.3 - Battery Charger**

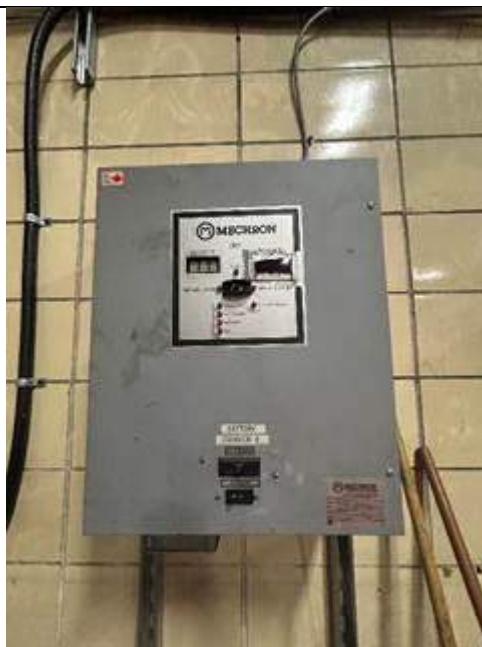
**Picture 4.4 - Battery Charger B**

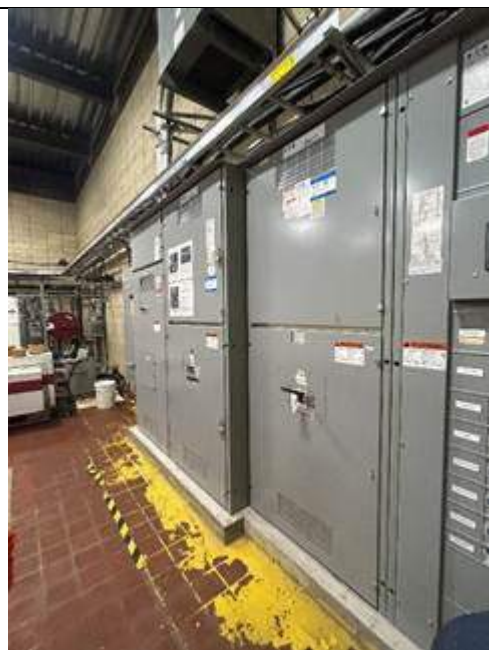
The incoming utility power is provided by three, single-phase pole top transformers via an overhead line. The main switchboard is an 800A, 480V switchboard (see Photo 4.5).which provides power to the building as well as the "MAINS SHOP MCC" and "COACH SHOP" via sub distribution panels (see Photo 4.6). The main electrical switchboard is free-standing and installed on a concrete housekeeping pad. Electrical feeders within the building appear to primarily be TECK cable, with some armoured cable installation and cable in conduit.

**Picture 4.5 - Main Switchboard**

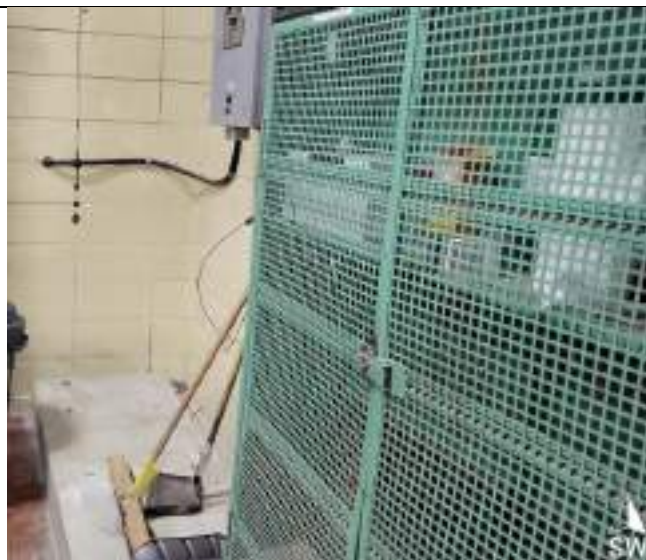
It was observed that most installed electrical equipment meets this 1 m requirement. However, it was observed that “BATTERY CHARGER B” fails to meet this requirement due to the installation of a concrete pad where a worker may accidentally step off the pad while working on the charger. (see Photo 4.7). This concrete pad fails the need for secure footing.

**Picture 4.7 - Concrete Pad**
