## APPENDIX G – REFERENCE REPORTS

| Description |
|---|
| Building Condition Assessment Report for Cochrane Powerhouse – September 19, 2022 – Prepared by Roth IAMS |

**Ontario Northland Transportation  
Commission**

**Building Condition Assessment Report**

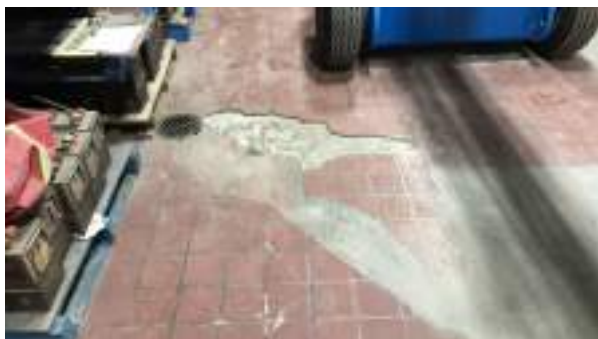
Damaged, missing, and stained quarry tiles were observed. Lifecycle replacement is recommended. Deferral of the replacement may result in the increase in potential of tripping hazards.

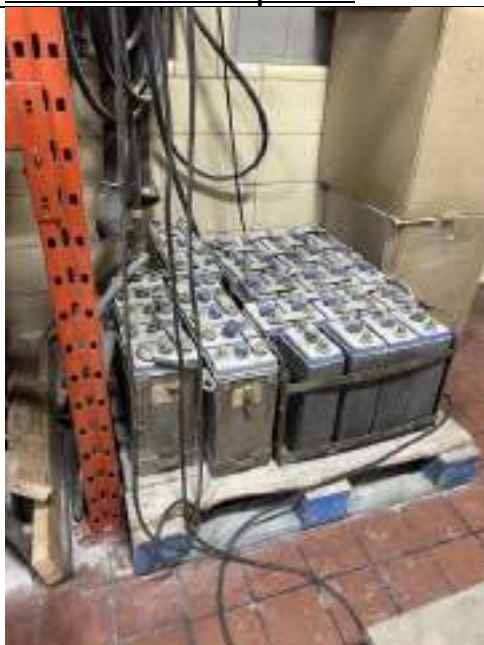
The facility also serves as a location for storage and charging of locomotive batteries. There were both lead-acid and nickel-cadmium (NiCd) batteries being stored at the time of the survey. Discussions with the ONTC have revealed that the NiCd (see Photo 3.3) are no longer being used or charged on site and are likely slated for disposal. Given this information, the further recommendations regarding battery ventilation are made referring only to the lead-acid batteries (see Photo 3.4). There were approximately 16 of these batteries being stored on site at the time of the survey. The facility is also equipped with two separate charging stations, although only one is now being used (see Photo 3.5).

**Picture 3.3 - Nickel-cadmium (NiCd) batteries**

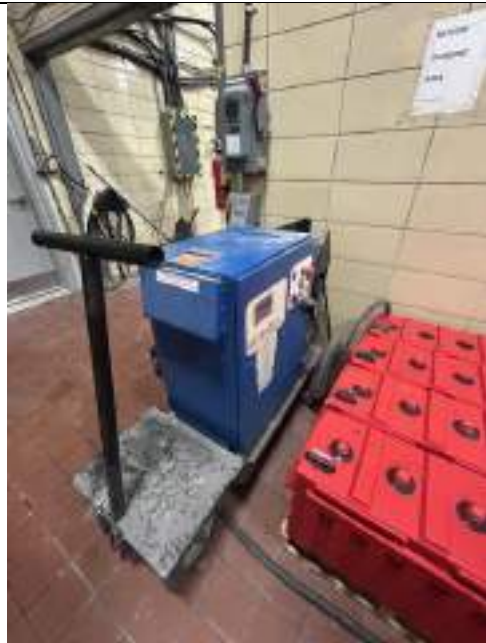
Picture 3.5 - Charging station being used

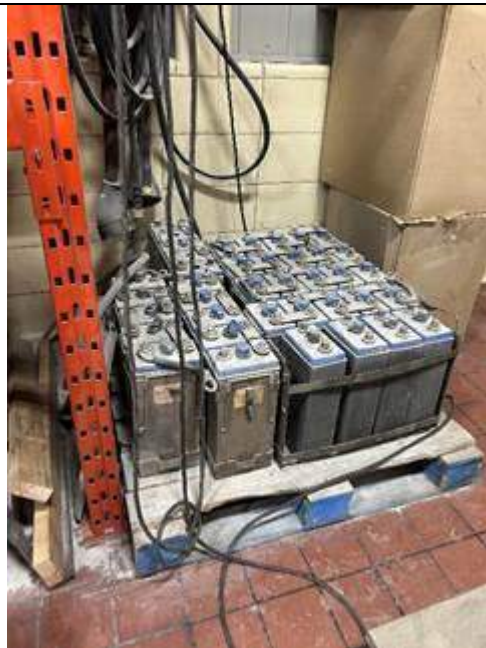
Picture 4.1 - Batteries

Lead-acid and NiCd batteries are stored and charged within the building placed on the floor, as well as on wooden pallets (see Photo 4.1 and Photo 4.2). Batteries are charged with a portable industrial battery charger, (see Photo 4.3), as well as a wall mounted battery charger "BATTERY CHARGER B" (see Photo 4.4)

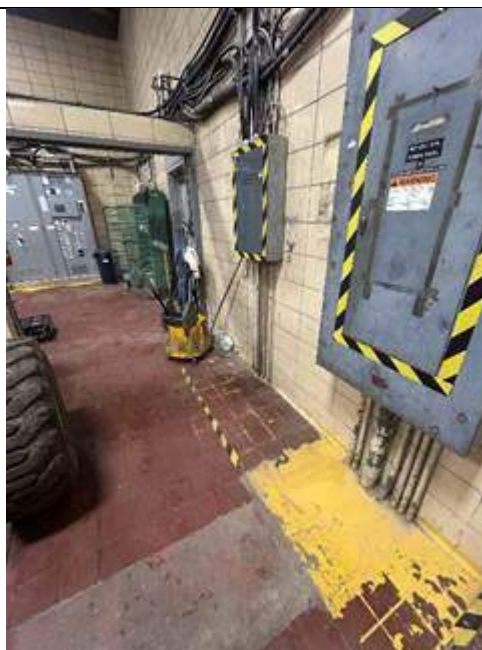
The incoming utility power is provided by three, single-phase pole top transformers via an overhead line. The main switchboard is an 800A, 480V switchboard (see Photo 4.5).which provides power to the building as well as the "MAINS SHOP MCC" and "COACH SHOP" via sub distribution panels (see Photo 4.6). The main electrical switchboard is free-standing and installed on a concrete housekeeping pad. Electrical feeders within the building appear to primarily be TECK cable, with some armoured cable installation and cable in conduit.

**Picture 4.6 - Distribution Panels**
